**Developing an approach for analysing the
possible impact of natural hazards on cultural
heritage: a case study in the Upper Svaneti
region of Georgia**

Antoni Alcaraz Tarragüel
March, 2011

Level: Master of Science (MSc)

Thesis submitted to the University of Twente, faculty ITC, in partial fulfilment of
the requirements for the degree of Master of Science in Geo-information Science
and Earth Observation for Environmental Modelling and Management

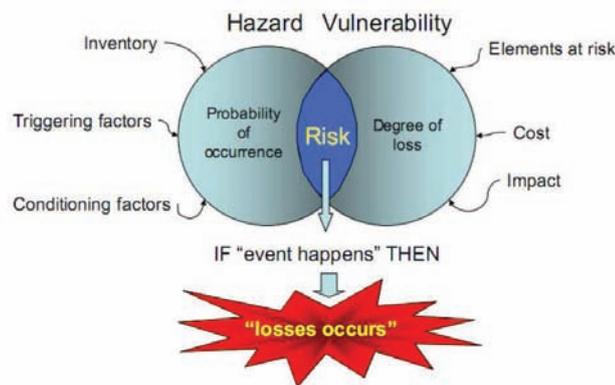
Figure 2.1: Graphical representation of risk and its consequences (Alexander, 2002, cited in Castellanos Abella, 2008a).

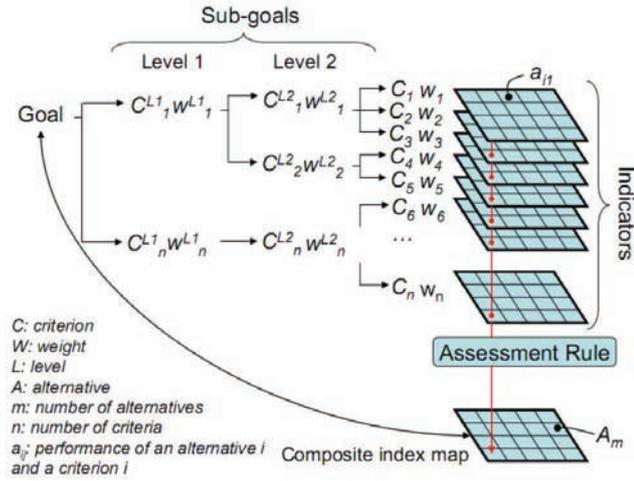
Figure 2.2: Schematic procedure for spatial multi-criteria evaluation based on the analytical hierarchical process (Castellanos Abella, 2008a, van Westen, 2009).

The composite risk index map is obtained by an assessment rule (sometimes also called decision rule), which is calculated by adding up the performance of all cell values of the different criteria (a_{ij}) for the particular alternative. However, the performance of every element in the matrix (a_{ij}), is obtained in a different way:

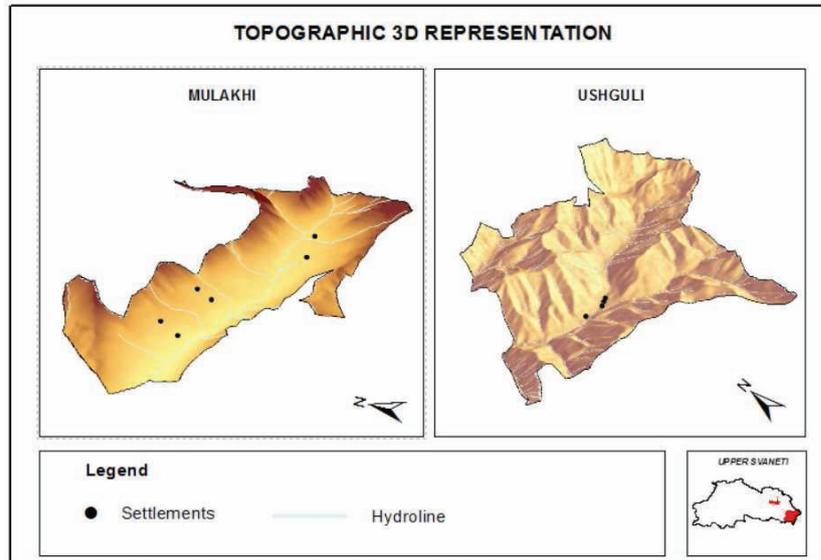
Figure 3.2: 3D representation of the study areas.

The study area has a pronounced and complex relief (Figure 3.2). In Ushguli, approximately 72% of the area is steep with gradients between 20° and 40°. In Mulakhi, more than half of the area (55%) falls under that range. The settlements in Ushguli are all found on the lower part of the valley whereas in Mulakhi four of the six villages visited are found directly on the slopes; the other two settlements being in a flatter location. At altitudes higher than 1500 m above MSL, mainly paleo-glacial relief with trough gorges and moraines is developed within the area of study. Erosion landforms are also significant; they are found in the area that was left when the glaciers retreated. Narrow and deep canyons and gorges are typical for these formations. Numerous debris cones, formed by periodic mudflows, are found at the bottom of the eroded gorges. Riverine terraces located on various altitudes are also present in some locations (GPAP-Georgia Protected Areas Development Project, 2008).

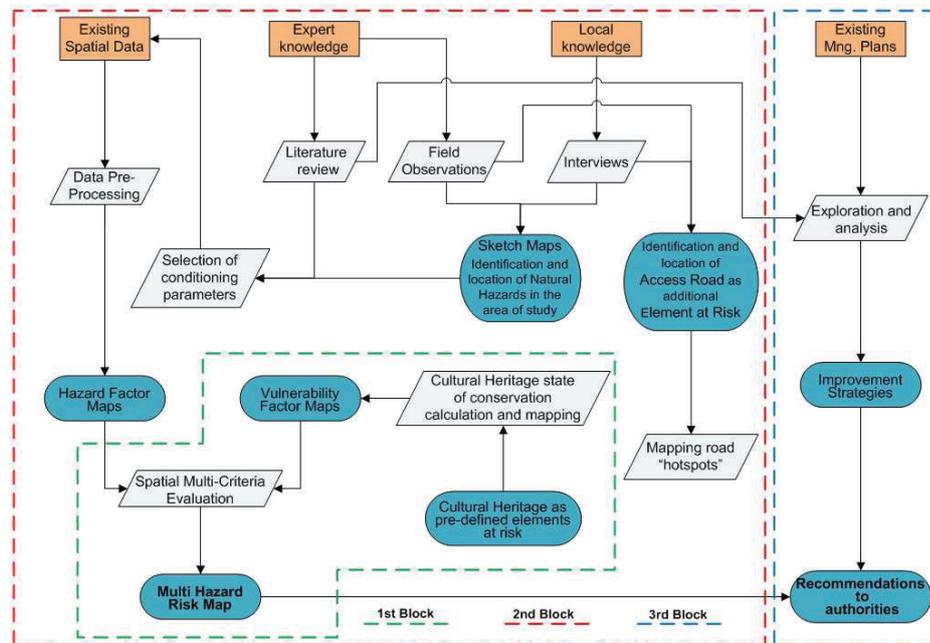
Figure 4.1: Schematic flow of the overall research process

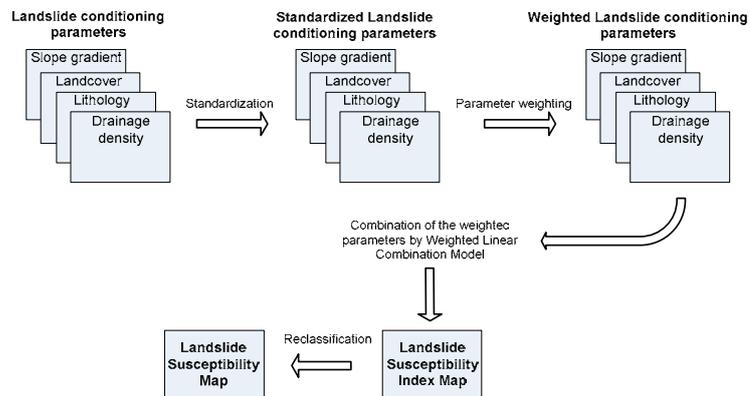
Figure 4.2: Hazard susceptibility analysis approach (example for landslide).

A hazard susceptibility analysis was performed in turn for landslides and avalanches in the communities of Ushguli and Mulakhi. The methodology followed (Figure 4.2) is the same for each community and natural hazard, only varying the conditioning factors used for landslides and avalanches.

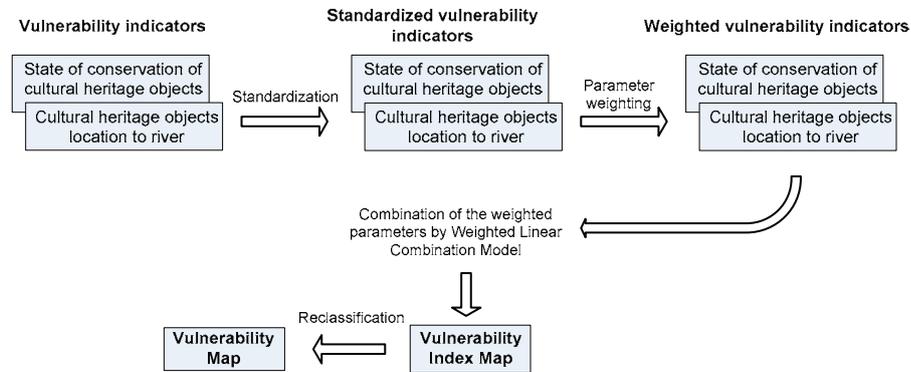
Figure 4.3: Vulnerability analysis approach (example for Ushguli).

Two vulnerability analyses were performed in turn for Ushguli and Mulakhi. Figure 4.3 shows the vulnerability analysis approach.

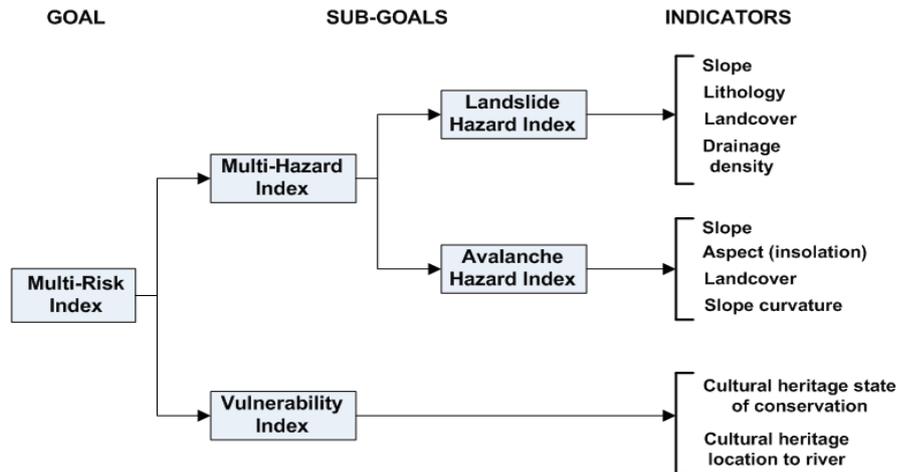
Figure 4.4: Multi-risk analysis approach in this study.

The main objective of the multi-hazard risk mapping is to provide a global view of the expected damage due to the potential landslide and avalanche hazard by identifying the most vulnerable cultural heritage objects that are threatened. Figure 4.4 shows the multi-hazard risk analysis approach adopted in this study.

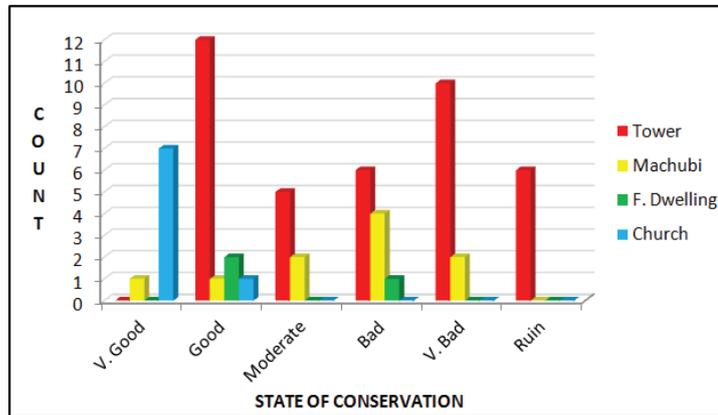
Figure 5.1: Summary results of the state of conservation assessment.

Information about the state of conservation of 60 cultural heritage objects was collected in Ushguli and Mulakhi communities (30 objects in each community). A total number of 116 cultural heritage objects are listed in Ushguli (GPAP, 2008). In this study, 26% of the total cultural objects in Ushguli community were surveyed. According to the same source 99 cultural heritage objects are found in the six villages assessed in Mulakhi community meaning that 30% of the total cultural heritage objects were surveyed. One object in Ushguli and five in Mulakhi were directly assessed as “Ruin”. More than half (61.7%) of the objects for which information was collected were towers, followed by machubis (20%). Churches and fortified dwellings accounted for 13.3% and 5% respectively. Figure 5.1 below depicts graphically a summary of the results of the state of conservation assessment.

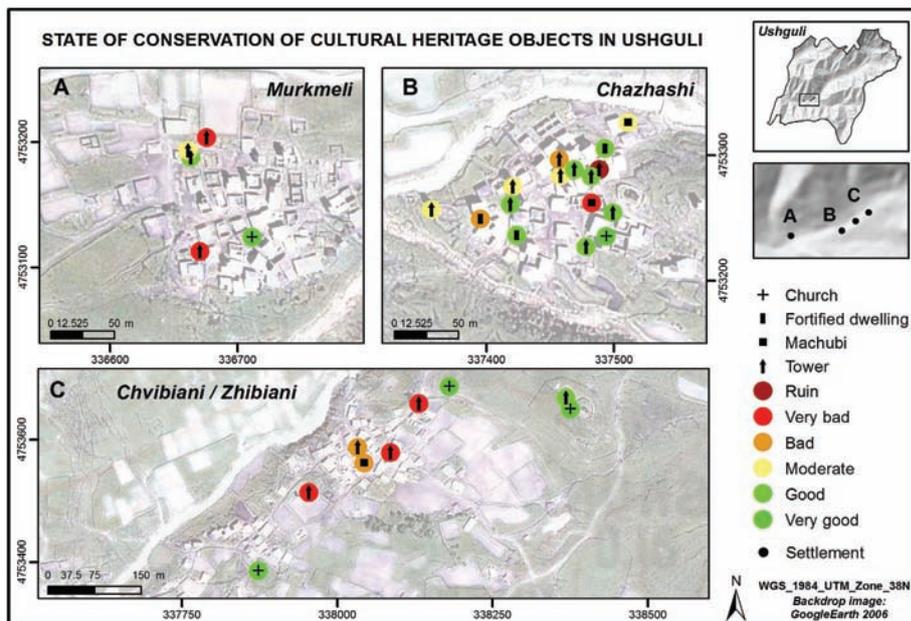
Figure 5.3: State of conservation for 30 cultural heritage objects in villages in Ushguli.

Figures 5.3 and 5.4 below represent the state of conservation of cultural heritage objects in Ushguli and Mulakhi communities respectively. The maps depict the state of conservation of the cultural heritage objects assessed from “very good” to “ruin”, as well as the typology of the objects. For example, in Murkmeli village (Ushguli) it can be observed that there are two towers in red, meaning that they are in a very bad state of conservation; a church (cross sign) in green showing a very good state of conservation; and two other towers with good and moderate level of conservation (lighter green and yellow respectively). A backdrop image of enough quality could not be found for the state of conservation map in Mulakhi community.

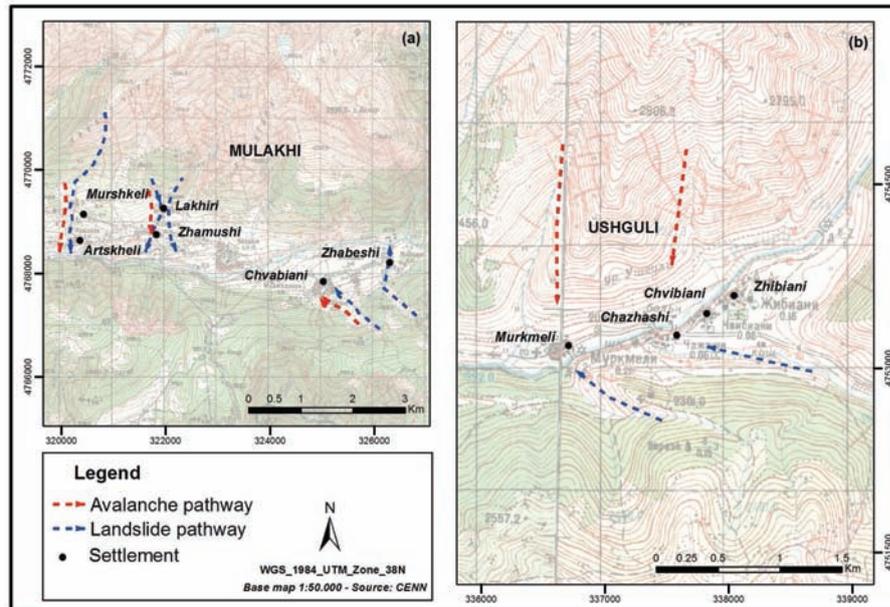
Figure 6.1: Location and pathways of landslides and avalanches according to local knowledge in the study area: (a) Mulakhi; (b) Ushguli.

As concluded from information extracted from local knowledge as well as expert knowledge and field observations, the two major natural hazards identified in the study area are avalanches and landslides. Figure 6.1 below shows the location and pathways of landslides and avalanches according to local knowledge (interviews) in the study areas.

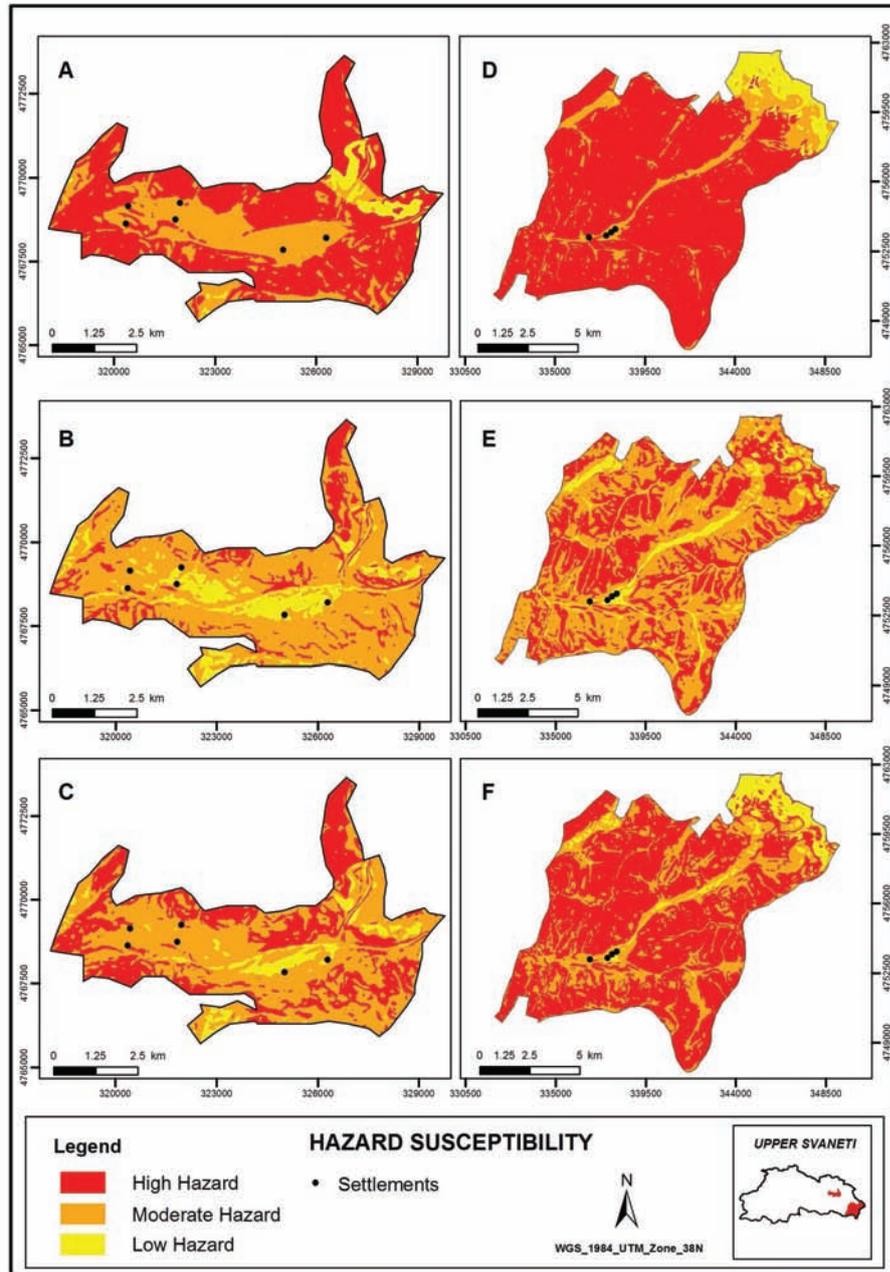
Figure 6.2: Hazard susceptibility in the study area. Mulakhi: Landslide, avalanche and multi-hazard (A, B and C respectively). Ushguli: Landslide, avalanche and multi-hazard (D, E and F respectively).

A multi-hazard susceptibility analysis was performed using the spatial multi-criteria evaluation module within ILWIS. Three maps for each community resulted from the analysis: landslide susceptibility map; avalanche susceptibility map; and multi-hazard susceptibility map (combining landslide and avalanche susceptibility) (Figure 6.2 A, B and C for Mulakhi; D, E and F for Ushguli). Table 6.1 below shows also the percentage of the total area with low, moderate and high hazard susceptibility per each type of hazard and for both hazards combined (multi-hazard) in the study areas. Figure 6.2 and Table 6.1 will be discussed in the next section.

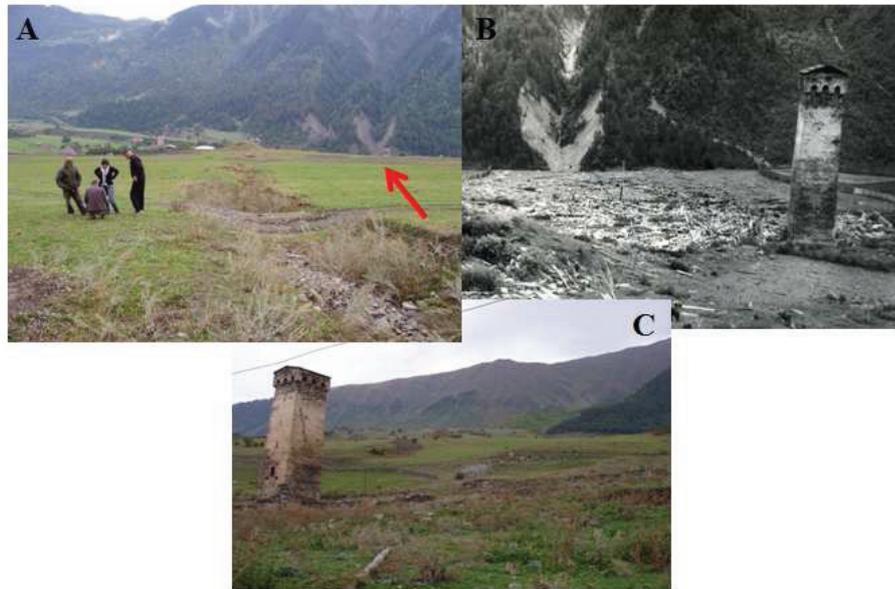
could be recognised as, for example, minor recent events that left scars on some buildings and, above all, a major avalanche event that occurred in 1987 in the community of Mulakhi resulting in the destruction of several buildings and 27 people dead. The avalanche had a volume of 1500000 m³ and a height of 80-100 cm (Irakli Megrelidze, personal communication, 13th January, 2010). Figure 6.3 below shows the avalanche event of 1987: (A) avalanche pathway as indicated by locals (red arrow); (B) avalanche destruction soon after it happened; (C) present signs of the avalanche (ruins, debris).

Figure 6.3: 1987 avalanche event in Zhamushi (image B courtesy of Irakli Megrelidze).

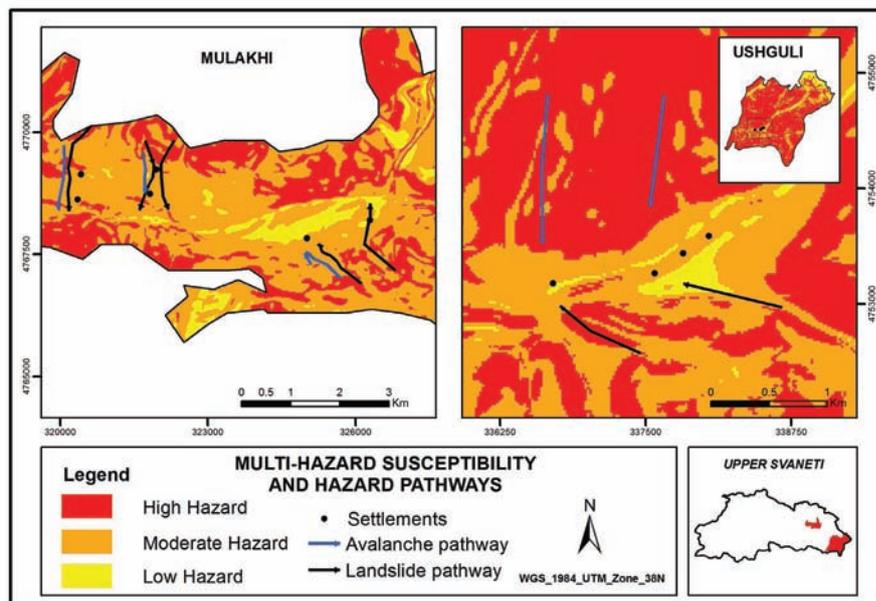
Figure 6.4: Avalanche and landslide pathways extracted from local knowledge overlaid on top of the multi-hazard analysis result.

areas within the community. Avalanches represent mainly a moderate hazard for both communities. In Mulakhi the percentage in this class is higher compared to Ushguli mainly because the slopes in Mulakhi present less curvature and also due to the more abundance of forested areas in Mulakhi offering some degree of protection. Overall, the multi-hazard analysis shows that Ushguli have a higher level of hazard susceptibility compared to Mulakhi. These results were visually compared overlaying them with the hazards pathways indicated by locals (Figure 6.4). From this comparison it can be observed that the location of the avalanche and landslides pathways indicated by the people interviewed matches to a large extent with the areas of higher level of avalanche and landslide susceptibility extracted from the analysis. Consequently, it could be affirmed that the hazard factor maps used in the SMCE proved to be a good choice as well as the weights given to the different factors.

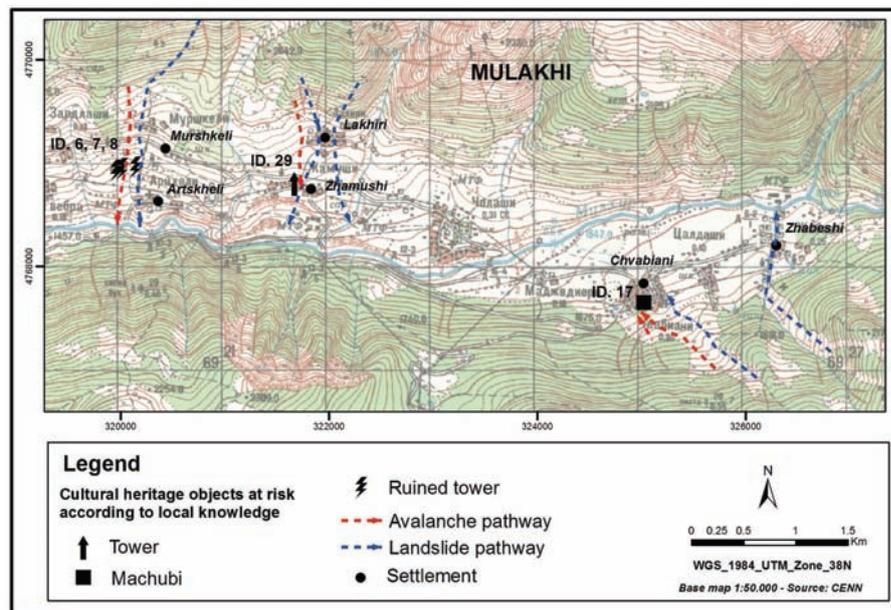
Figure 6.5: Cultural heritage objects at risk according to locals (Mulakhi).

Once in the study area, the message from the local community was similar. In Ushguli, no cultural heritage objects were identified by the local community as being at risk of avalanches and landslides. In Mulakhi however, some objects were identified as being at risk (Figure 6.5): Object Id 17 and Object Id 29. The latter object is the tower that survived the 1987 avalanche mentioned earlier. Objects 6, 7 and 8 are towers in a ruined state. These objects are in the very middle of avalanche and landslides pathways.

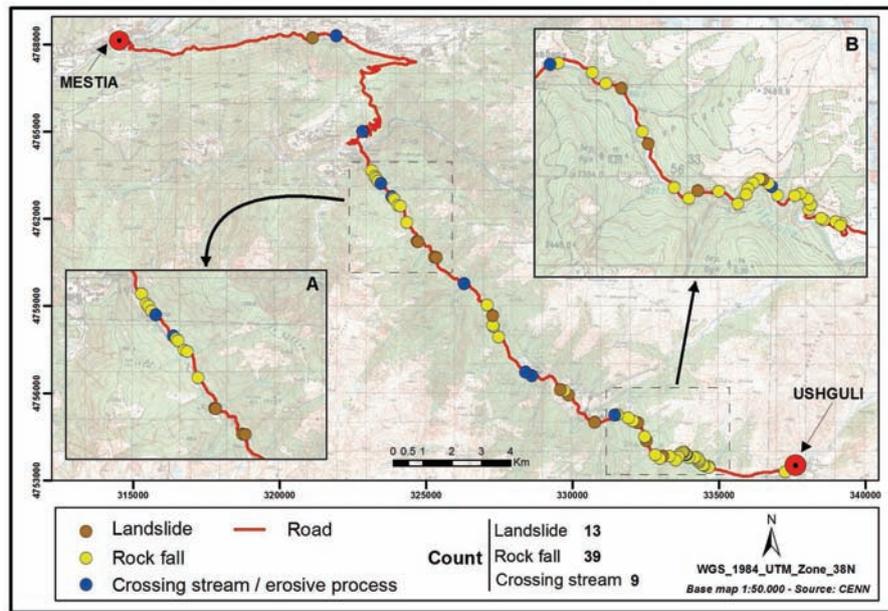
Figure 6.6: 61 identified road *hot spots* along the road from Mestia to Ushguli.

Mulakhi community. Figure 6.6 below shows 61 *hot spots* identified during the field work (see also Figure 6.7) along the road from Mestia to Ushguli that could cause blockages and hence indirectly influencing the integrity of cultural heritage (see also section 3.7 and 4.4.1).

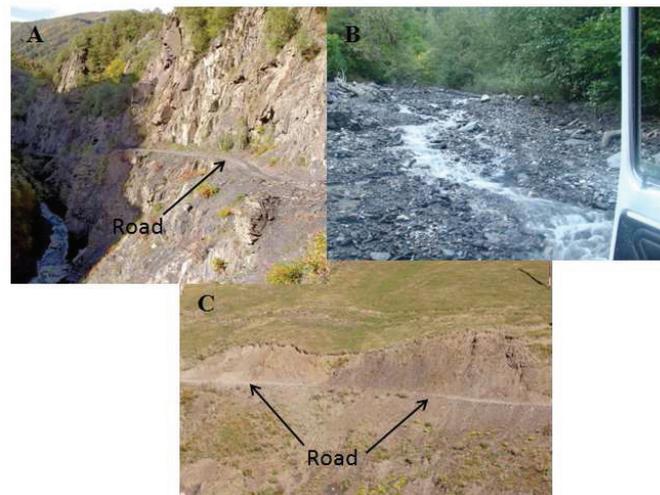
Figure 6.7: Hotspots examples of: (A) Rockfall; (B) Stream crossing road; (C) Landslide.

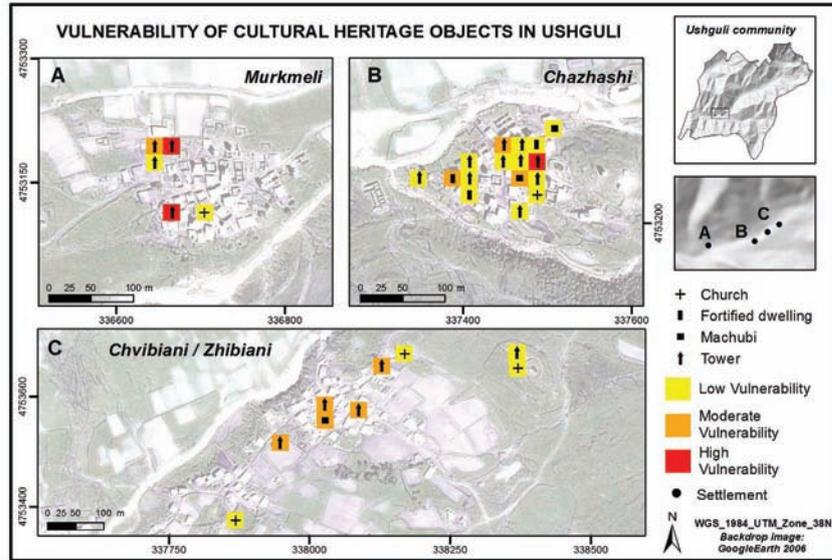
Figure 6.8: Landslide and avalanche vulnerability of cultural heritage objects in Ushguli.

Figures 6.8 and 6.9 show landslide and avalanche vulnerability of cultural heritage objects in Ushguli and Mulakhi respectively.

In Ushguli community vulnerability was calculated based on the state of conservation of cultural heritage objects and on the location of the objects in relation to the river. 19 out of 30 objects show low vulnerability and only 3 objects have high level of vulnerability due to their especially advanced state of deterioration. Two of those high vulnerability objects are located on the right side of the river Enguri in Murkmeli hence having an additional degree of vulnerability. The overall vulnerability of the cultural heritage objects in Ushguli is quite favourable as many of these objects (especially in Chazhashi village) have benefited in the last years of recovery and maintenance works. In Mulakhi 12 out of 30 objects have low vulnerability whereas 4 are high vulnerable. Churches are globally the cultural heritage object less vulnerable.

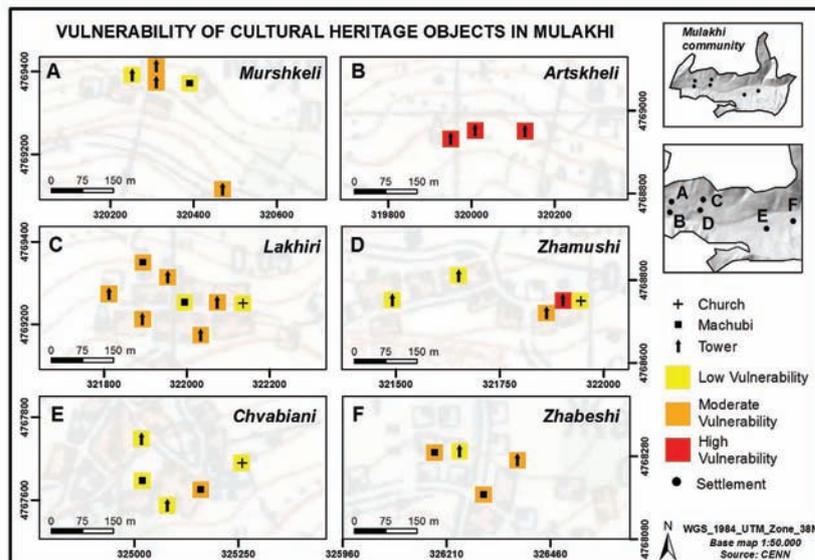
Figure 6.9: Landslide and avalanche vulnerability of cultural heritage objects in Mulakhi.

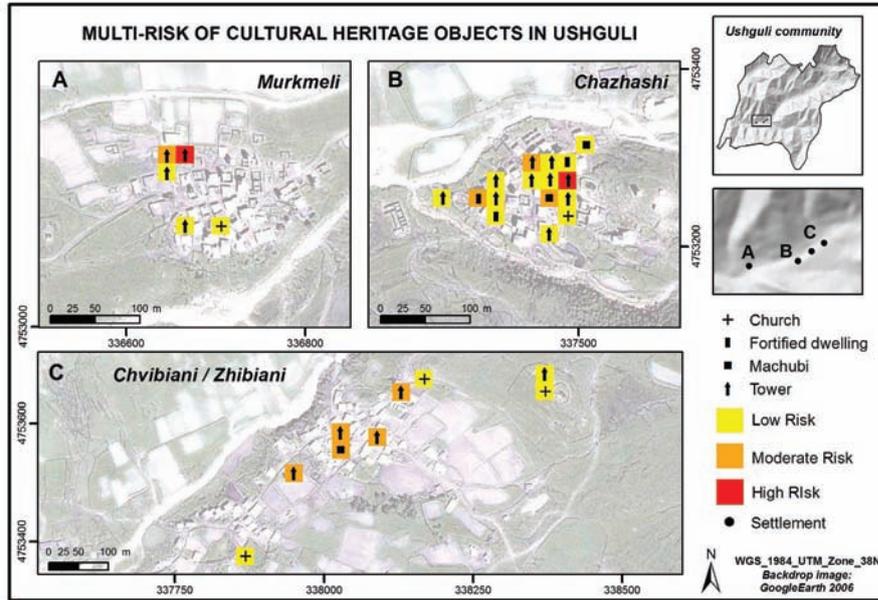
Figure 6.10: Multi-risk (landslide and avalanche) of cultural heritage objects in Ushguli.

Figures 6.10 and 6.11 below show the risk of cultural heritage objects to landslides and avalanches combined (multi-risk) (see Appendix 1 for maps of cultural heritage objects risk to landslides and avalanches separately for each community).

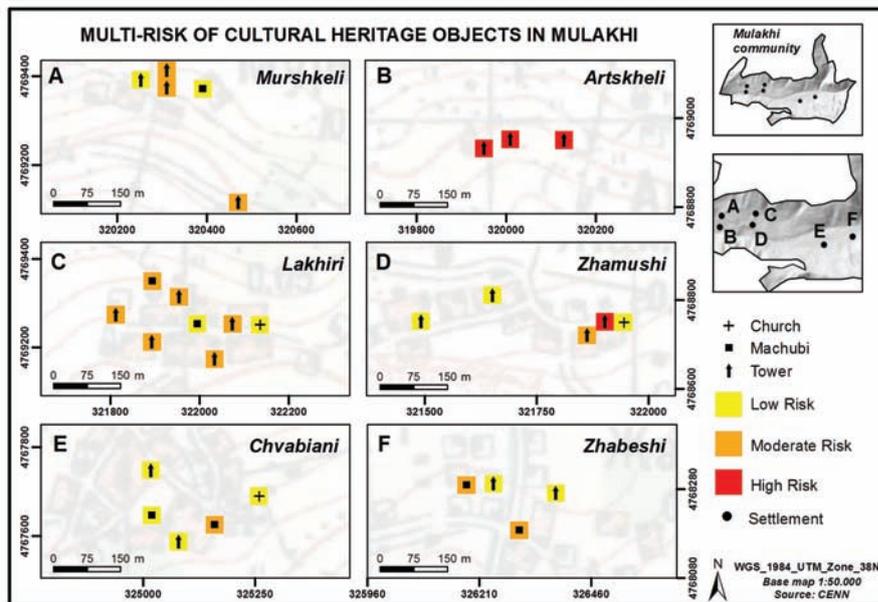
Figure 6.11: Multi-risk (landslide and avalanche) of cultural heritage objects in Mulakhi.

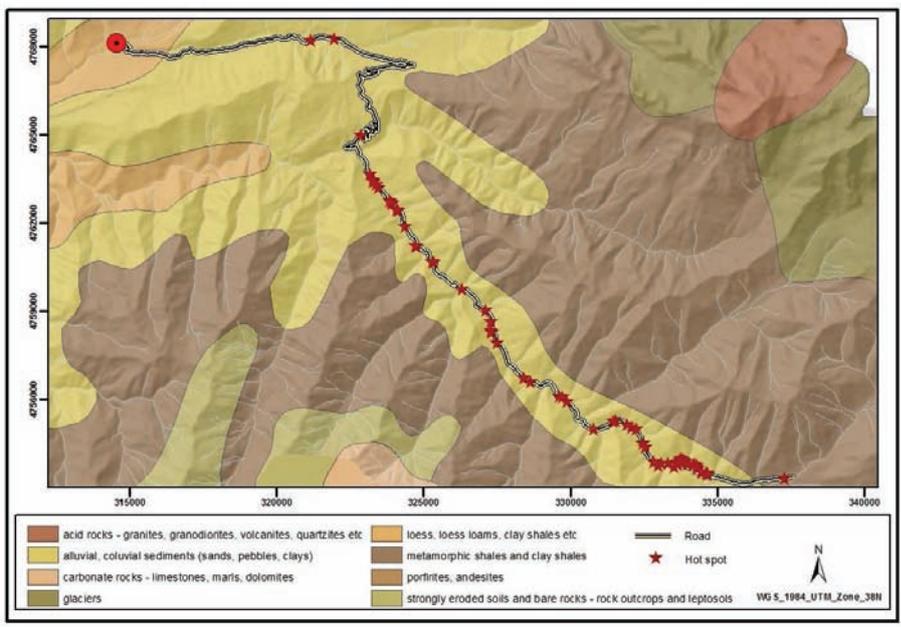
SOIL TYPE ALONG THE ROAD FROM MESTIA TO USHGULI:

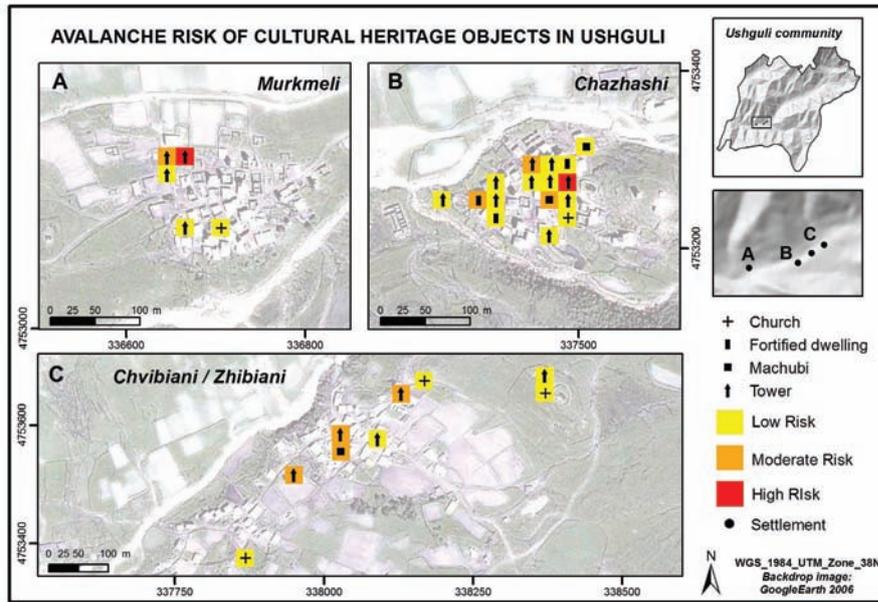
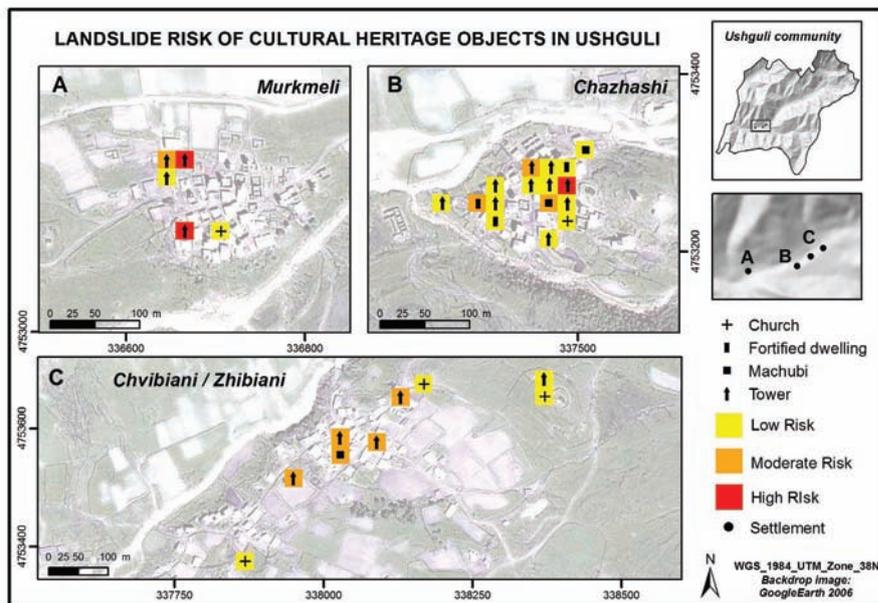
AVALANCHE AND LANDSLIDE RISK FOR CULTURAL HERITAGE OBJECTS IN USHGULI:

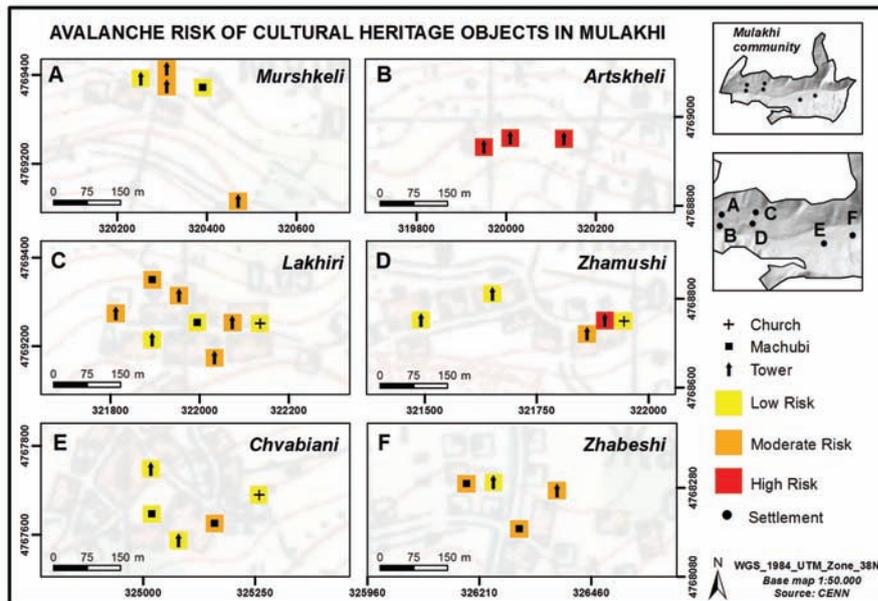
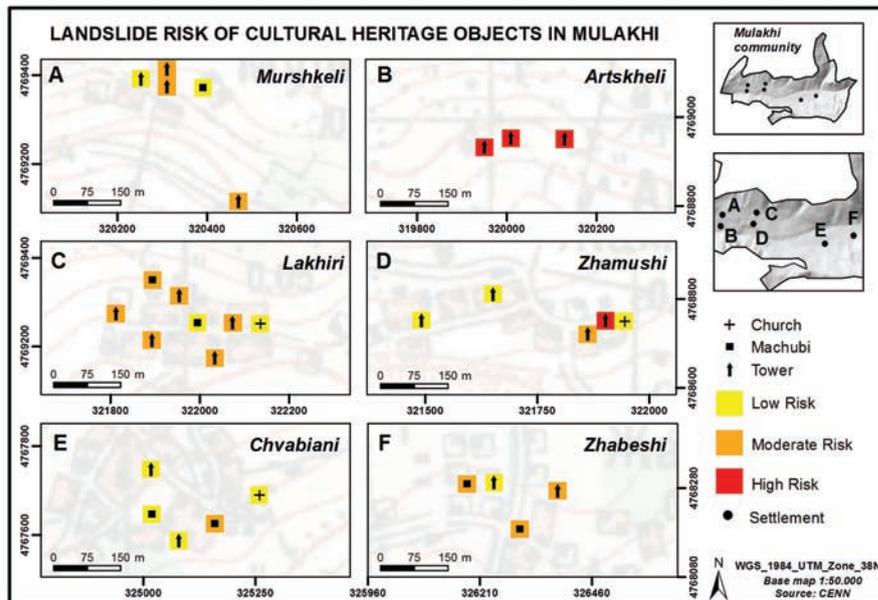
AVALANCHE AND LANDSLIDE RISK FOR CULTURAL HERITAGE OBJECTS IN MULAKHI:

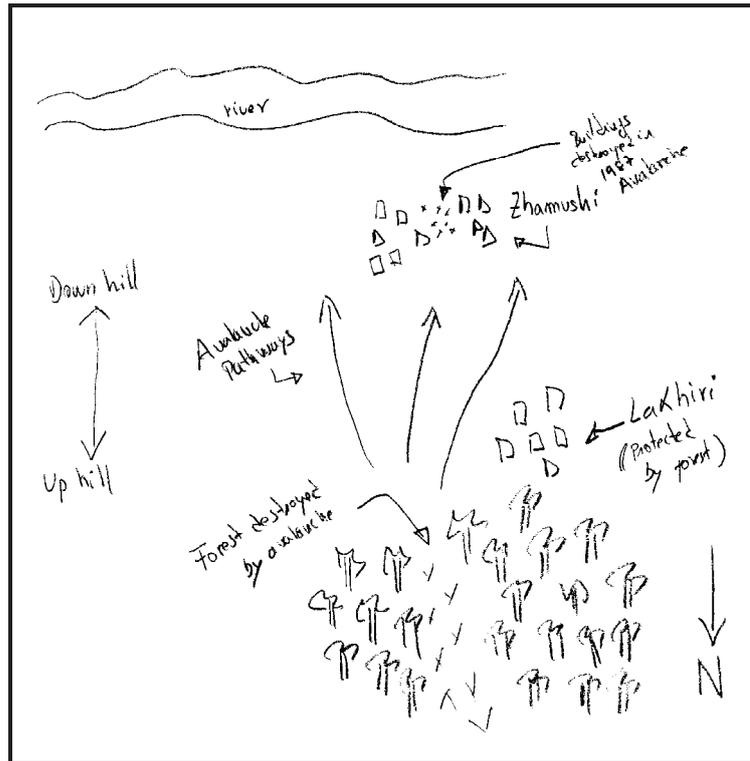
EXAMPLE OF SKETCH MAP PRODUCED IN THIS STUDY

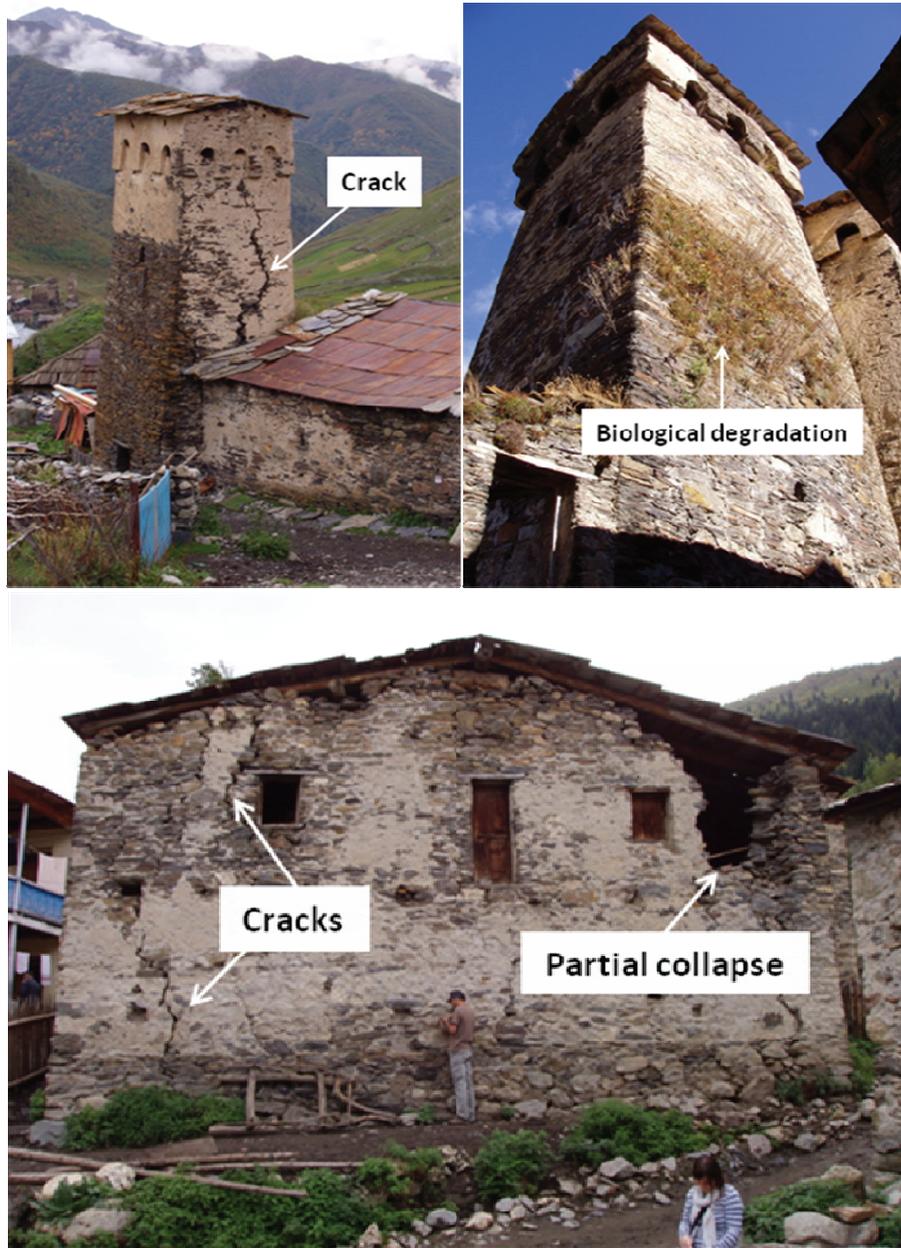
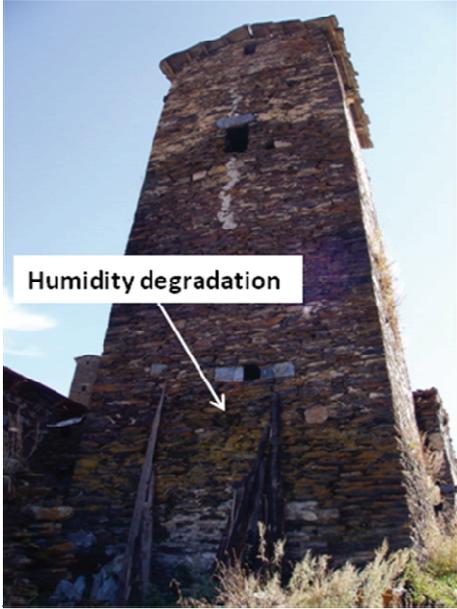
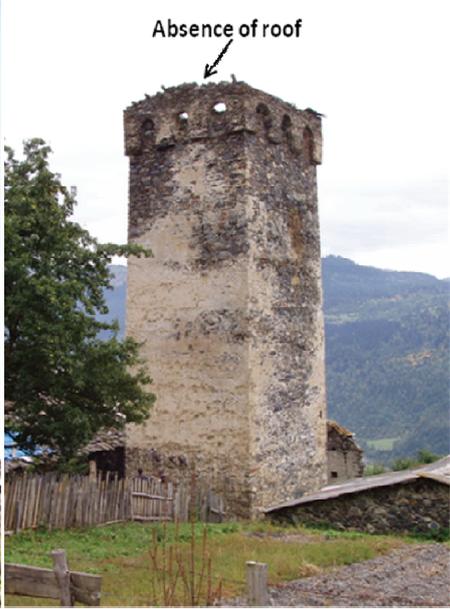
EXAMPLES OF DAMAGE ELEMENTS

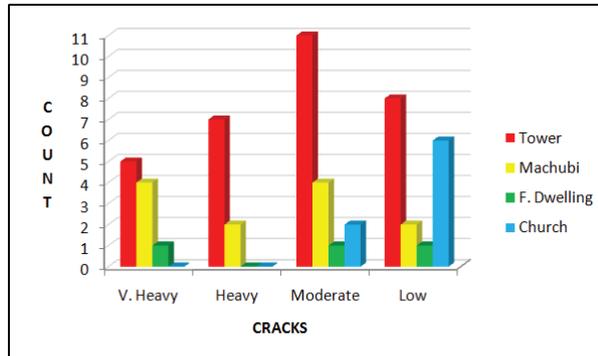
Crack damage vs. state of conservation
